Characterization of Rubblized Concrete Pavements with HMA Overlays at the National Airport Pavement Test Facility

Gordon F. Hayhoe¹, Ph.D. and Navneet Garg², Ph.D.

Abstract

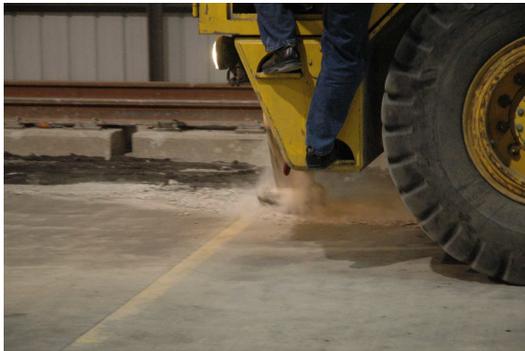
Figure 2. Rubblizing the north traffic lane with the resonant breaker.

In January, 2005, all of the concrete slabs in the north traffic lane, including those in the transition sections, were rubblized with an RMI RB-500 resonant breaker operating at 44 Hz. Then, in June, 2005, the rubblized pavement was lightly wetted, rolled with a vibratory steel drum roller, and overlaid with five inches of P-401 hot mix asphalt. Figures 2 through 5 show, respectively, the vibrating foot of the resonant breaker, the rubblized surface being rolled, the test pavement surface after rubblization, and the test pavement surface after overlaying (with the HWD equipment in position for uniformity testing).

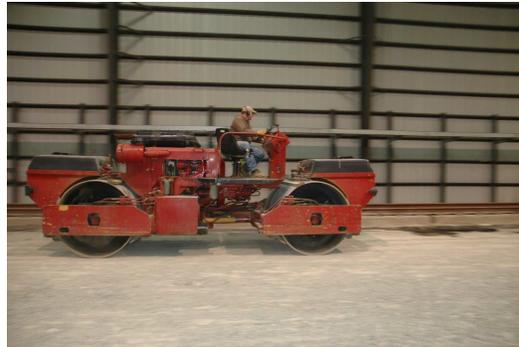
Figure 3. Rolling the rubblized pavement.

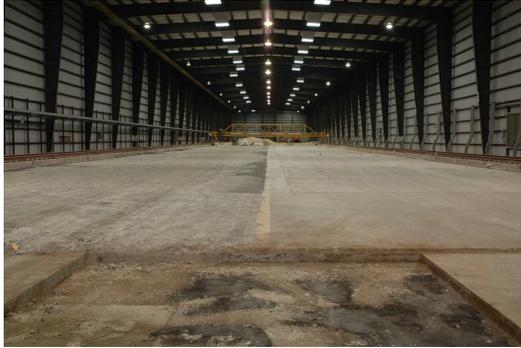
Figure 4. Rubblized on the left (north) as-trafficked on the right (south).

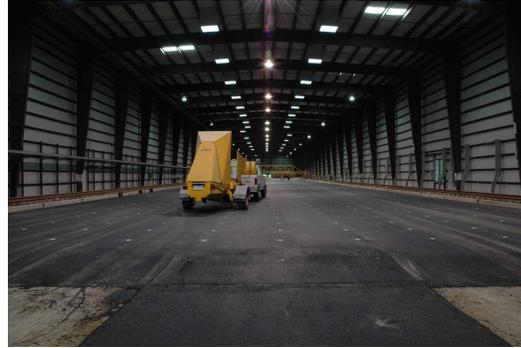
Figure 5. After asphalt overlay, with HWD equipment in foreground.

Heavy-weight deflectometer (HWD) tests were performed using the FAA's HWD equipment on a 10-foot (3.05 m) grid to study the uniformity of the pavement structures, see figure 5. Tests were performed with a 12-inch diameter plate at three different load levels – 12,000, 24,000, and 36,000 lbs (53.4, 106.8, and 160.2 kN). The results showed that the pavement structure within each test item was fairly uniform. For peak center deflection (D0), the coefficient of variation (COV) ranged between 20 to 25 percent. For deflection D7 (at 72-inch (182.9-cm) offset from the center of load plate, and an indicator of subgrade condition), the COVs were around 10 percent. Figure 7 shows that the mean peak center deflections (D0s) for the rubblized test items were larger than the D0 deflections for the unrubblized test items. Also, among the rubblized test items, MRC showed the highest deflections, followed by MRG and then by MRS. This order was counter to expectations because MRC had a crushed aggregate subbase course and would normally be expected to be of higher stiffness than the MRG pavement built directly on the subgrade. Pretraffic measurements of subgrade strength in the test pits showed that water had migrated from the crushed aggregate subbase into the subgrade of MRC and softened the top three or so inches of the subgrade. The surface of the subgrade in the MRC test pits had a strength of approximately 4 CBR whereas the strength one foot (30 cm) below the surface was approximately 8 CBR. The surface of the subgrade in the MRG and MRS test pits was in the range 7 to 8 CBR, as constructed. The order of failure, discussed below, also followed the order of the HWD deflection magnitudes.

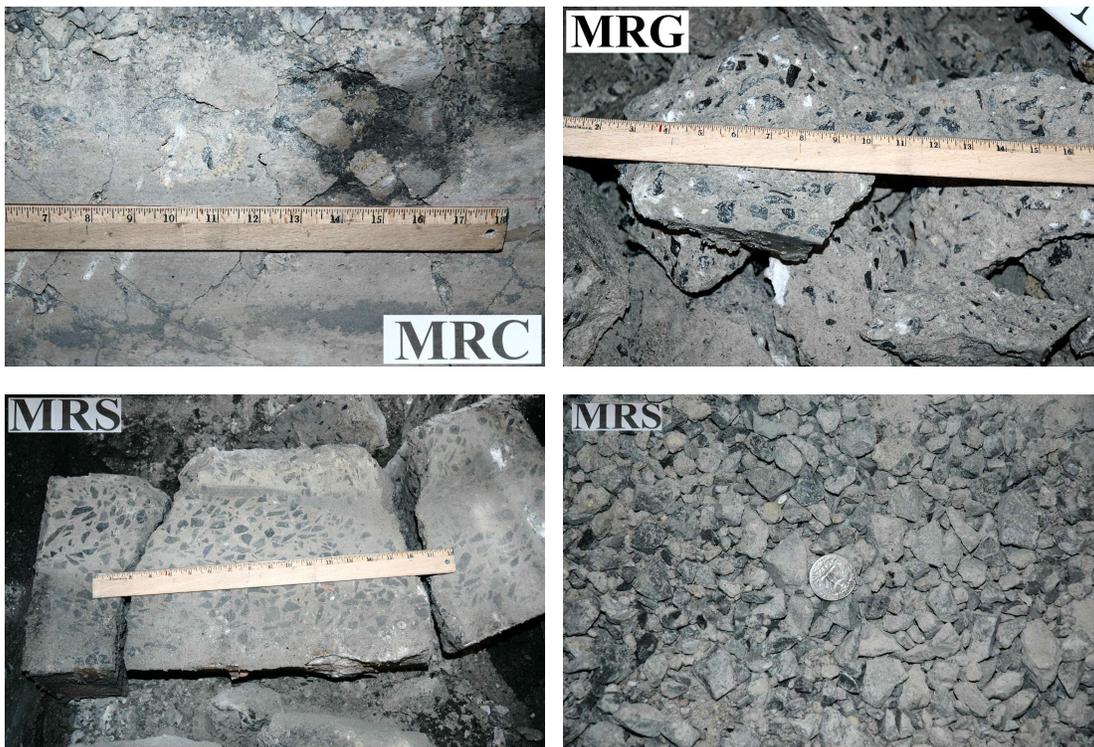
After the three test items were rubblized, a 4-foot (1.22 m) long by 4-foot (1.22 m) wide test pit was saw cut in each test item for visual examination of the rubblized concrete (extent of fractures from rubblization process, particle sizes, etc.). Figure 6 shows fracture patterns and particle sizes in test items MRC, MRG, and MRS respectively. In general, the top 2 to 3 inches (5 to 7.6 cm) in all the test items was rubblized into dust and stones with a top particle size of 1 inch (2.54 cm) (figure 6). The particle size in the bottom 9 inches (22.9 cm) ranged from 4 inches (10.16 cm) to 15 inches (38.1 cm) with larger particle sizes in MRS. The test pits showed that the rubblization process induced cracks/fractures for the entire depth of the slabs and that the cracks were tightly held.

Figure 6. Visual Observations from the Test Pits in Rubblized Test Items

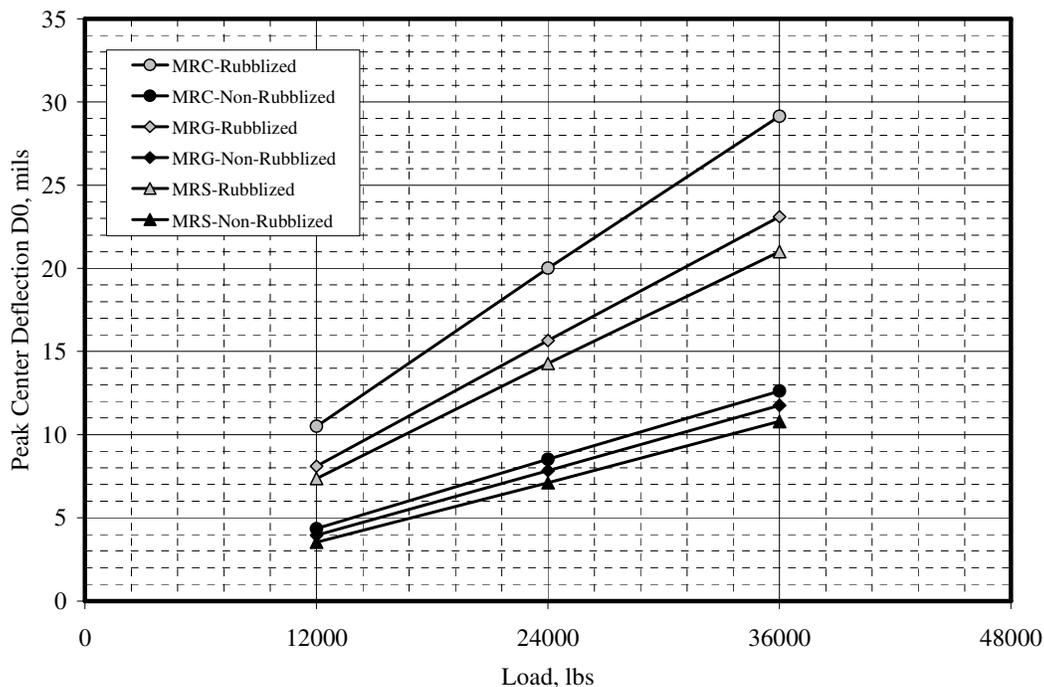
Figure 7. Mean Peak Center Deflections D0 from Uniformity Tests
(1 mil = 25.4 microns)

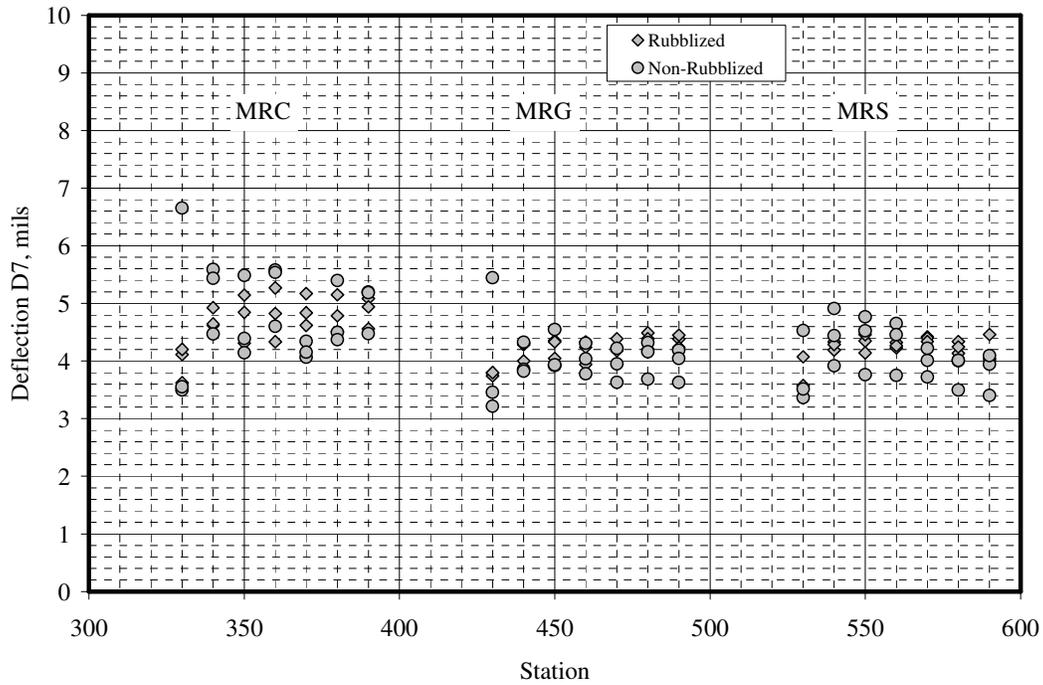
Figure 8 shows deflections D7 (at 72-inch offset from center of plate) that are indicative of subgrade stiffness. Figure 8 is further indication that the subgrade of MRC was of lower stiffness than the subgrade of MRG and MRS.

Figure 8. Deflections D7 from Uniformity Tests (1 mil = 25.4 microns)

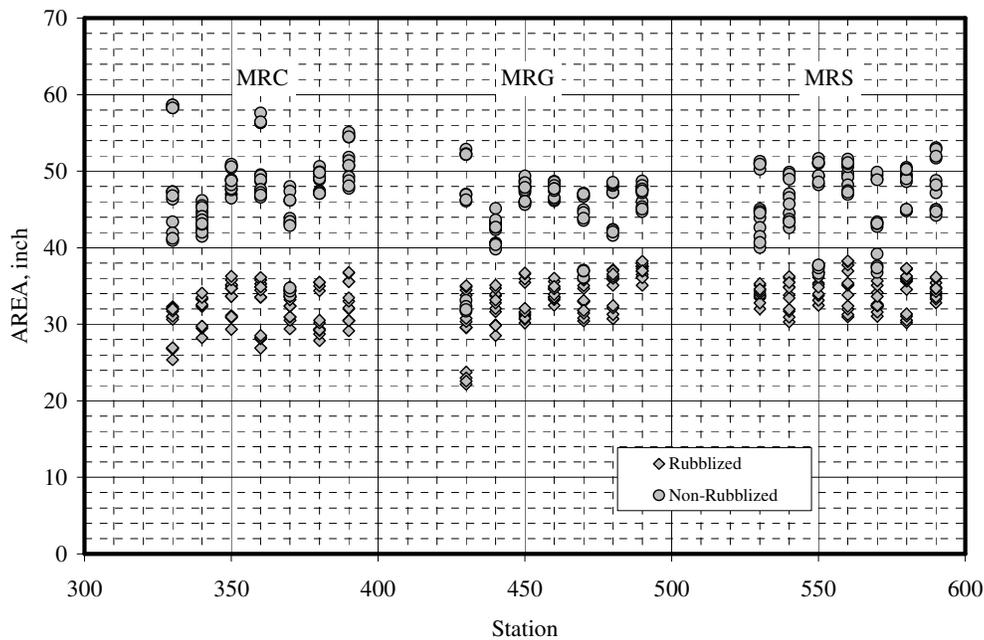
Figure 9 shows the AREA for rubblized and non-rubblized test items. AREA is the area of deflection basin normalized with D0 and is a deflection basin shape factor (Hoffman, 1981). The magnitude of the AREA term is a fairly good indicator of layer behavior (bound or unbound). Higher AREA values indicate bound material and lower AREA values indicate unbound material.

Figure 9. AREA from Uniformity Tests (1 inch = 2.54 cm)

The rubblized test items show lower AREA values (mean AREA = 33.2 inches, (84.3 cm)) compared to non-rubblized test items (mean AREA = 46.6 inches (118.4 cm)).

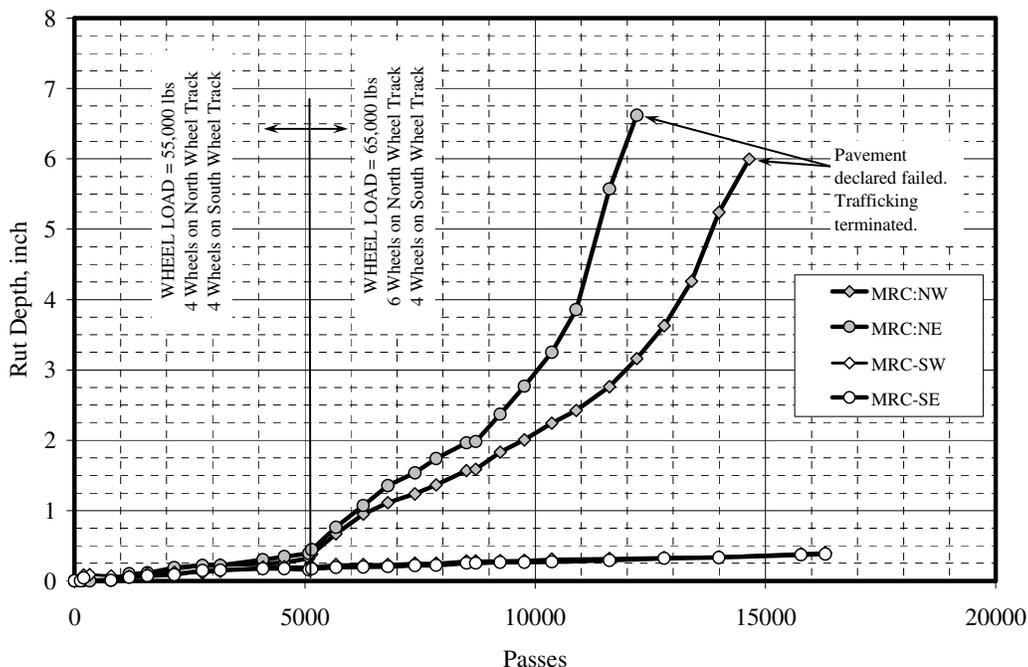
the test item. These locations were designated as NW and NE for the rubblized test items and SW and SE for the non-rubblized test items (N and S stand for north side and south side of the longitudinal centerline respectively). Figures 10 through 12 show the straightedge rut depth measurements for test items MRC, MRG, and MRS respectively.

Figure 10. Straightedge Rut Depth Measurements in MRC (1 inch = 2.54 cm)

Except at the MRS-SW location, all of the test items showed similar rut depths during the first 5082 passes (55,000-lbs wheel load, 4-wheel landing gear configuration). In particular, there was no discernible difference between the performance of the rubblized and non-rubblized pavements. It was also observed visually that the surface deflections of the rubblized pavements under load were negligible and the response of the rubblized pavements appeared to be very similar to that of the non-rubblized pavements. Instrumentation was not installed in the pavements to measure surface deflections so this observation cannot be verified to any degree of accuracy. But the surface deflection of a flexible pavement under load can be readily observed visually, and without any magnifying aid. The surface deflection of a rigid pavement cannot be observed visually. It was therefore decided that the load should be increased to the largest extent practically allowed by the test vehicle loading system and tires to increase the possibility of inducing significant distress in the rubblized pavements. From 5083 passes to the end of trafficking, six-wheel triple-dual-tandem loading at 65,000 lbs (29.5 tonnes) wheel load was applied to the rubblized pavement and four-wheel dual-tandem loading at 65,000 lbs (29.5 tonnes) was applied to the non-rubblized pavements. The six- and four-wheel configurations at increased loading both had the same dual and tandem spacings of 54 and 57 inches (137.2 and 144.8 mm).

After approximately 10,000 passes in MRC, 13,000 passes in MRG, and 15,000 passes in MRS, significant upheaval in the HMA layer at the longitudinal joints just outside the traffic path was observed in the rubblized test items. After this number of passes, the rut depth measurements are exaggerated because the straightedge was resting on top of the upheavals outside the traffic path. More accurate rut-depth measurements have been computed from the surface profile measurements. Maximum rut depths from the transverse profiles at the end of trafficking were 4 inches (10 cm) on MRC-N, 2.5 inches (6.4 cm) on MRG-N, and 2 inches (5.1 cm) on MRS-N. Significant structural upheaval was also observed outside the wheel track on MRC-N and MRC-N, but neither the straightedge measurement nor the transverse profile measurements can separate the contributions of the underlying structural response and the asphalt upheaval movement. Measurements of the transverse profiles of the structural layer interfaces are currently being analyzed from trench data. These measurements are expected to give a more definitive estimate of the true structural response of the rubblized pavement structures.

The NE end of MRC was the first area of the rubblized pavements to show signs of failure. This failure was not representative of the structural performance of the test item as a whole because one of the pre-overlay test pits (for subgrade evaluation) was located where the pavement failed. A weakened support system resulted because the replaced subbase aggregate material could not be compacted to the same density as in the original construction. A depression in the pavement surface was observed at this location after about 400 load repetitions. The depression migrated longitudinally towards the east until it was about 15 feet (4.6 m) long, but the structure continued to support the full traffic load until it appeared to be in danger of suffering complete structural collapse at 11,814 passes. The weakened area did not migrate back into the west half of the test item and the declared structural life of MRC-NW of 14,256 passes is believed to be a true representation of the structural performance of the test item. Also, MRC-NW did not appear to be in danger of complete structural collapse as had MRC-NE. Trafficking in MRG and MRS was terminated after 25,608 passes. From visual inspection at the end of trafficking, MRG-N appeared to be suffering from structural upheaval outside the wheel track but MRS-N did not. More definitive estimates of the structural condition of the test items will be possible after analysis of the posttraffic trench data.

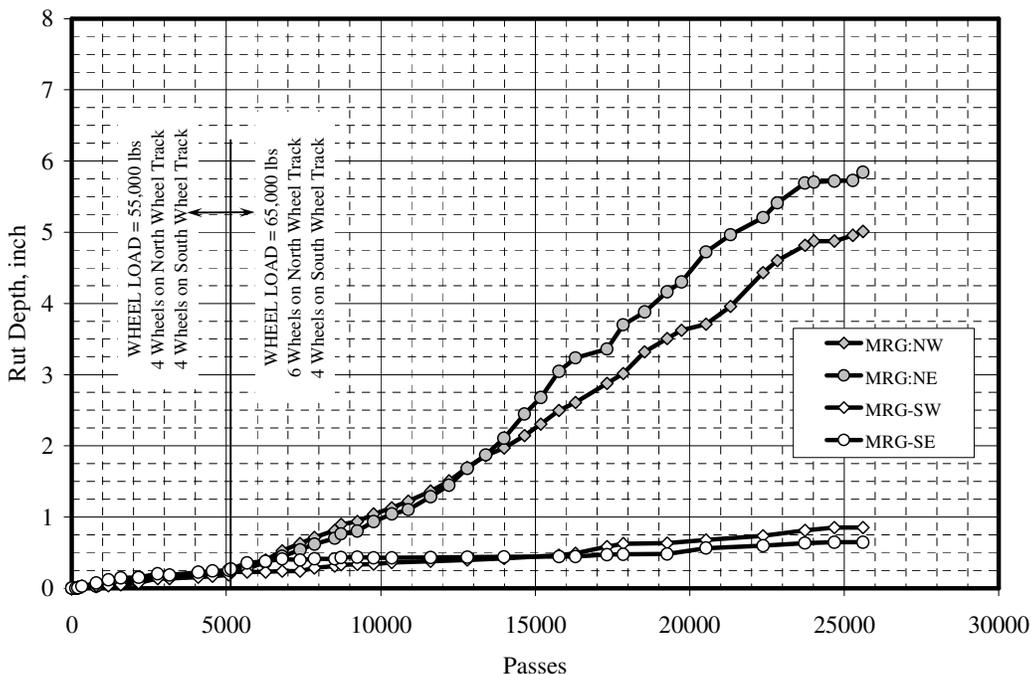
Figure 11. Straightedge Rut Depth Measurements in MRG (1 inch = 2.54 cm)

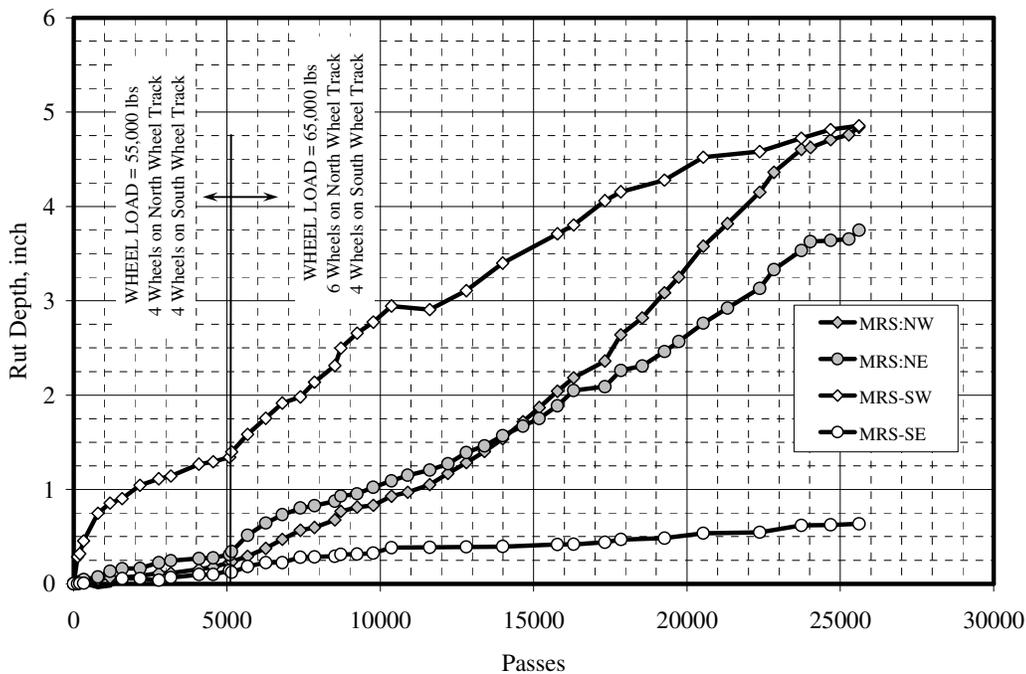
Figure 12. Straightedge Rut Depth Measurements in MRS (1 inch = 2.54 cm)

At the MRS-SW location (non-rubblized), a test pit (5-feet by 4-feet) was opened in the concrete slab (for subgrade evaluation) prior to the placement of the HMA overlay. The concrete that was used to re-fill the test pit was severely broken up and a depression formed at this location during the placement and compaction of the HMA

overlay. This severely weak area caused significant local accumulation of rutting during the early trafficking period.
